Manhole Inspection Summary

Manhole # S31AA_005MH

Insp Date: **12/14/07 2:02 PM**

Location Address: **821 MLK JR BLVD**

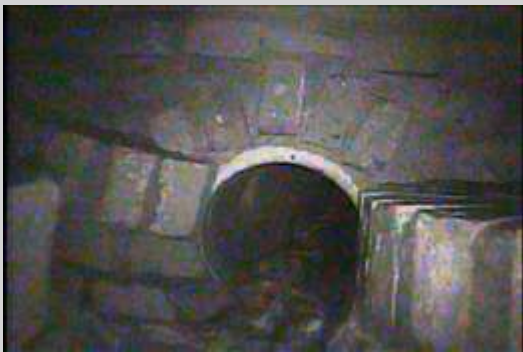
12 O'Clock Outflow

8 in. Circular Gravity Sewer
Pipe Out @ 12 O'Clock

Pipe Height: **8.4** (in.) Rod and Bar (Angled)
Pipe Material: **Clay** ☐ Pipe Lined
Invert Depth: **12.23** (ft.) Flow Characteristics: **Slow**
Deposits: ☒ None ☐ Mud ☐ Sludge ☐ Debris ☐ Grease
Silt Depth: (in.) Deposits Extent:
Infiltration: **None** Pipe Seal Cond: **Sound**

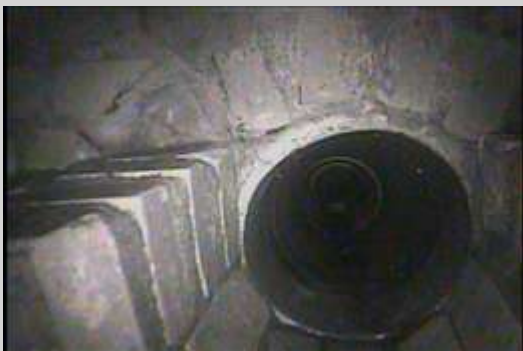
3 O'Clock Inflow

8 in. Circular Gravity Sewer
Pipe In @ 3 O'Clock

Pipe Height: **8.4** (in.) Rod and Bar (Angled)
Pipe Material: **Clay** ☐ Pipe Lined
Invert Depth: **11.97** (ft.) Flow Characteristics: **Slow**
Deposits: ☒ None ☐ Mud ☐ Sludge ☐ Debris ☐ Grease
Silt Depth: (in.) Deposits Extent:
Infiltration: **None** Pipe Seal Cond: **Sound**

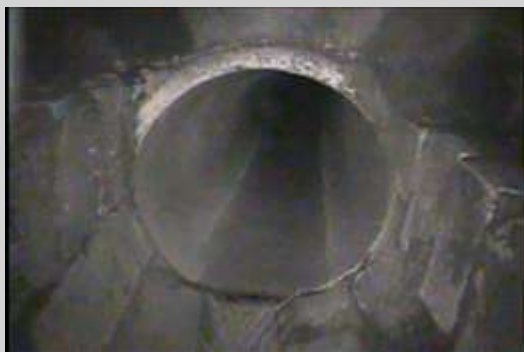
9 O'Clock Inflow

8 in. Circular Gravity Sewer

Pipe In @ 9 O'Clock

Pipe Height: **8.4** (in.) Rod and Bar (Angled)

Infiltration: **None** Pipe Seal Cond: **Sound**
